## Continuous Strain Monitoring in the Rock Foundation of a Large Gravity Dam

K. Kovári

G. Peter

### Summary

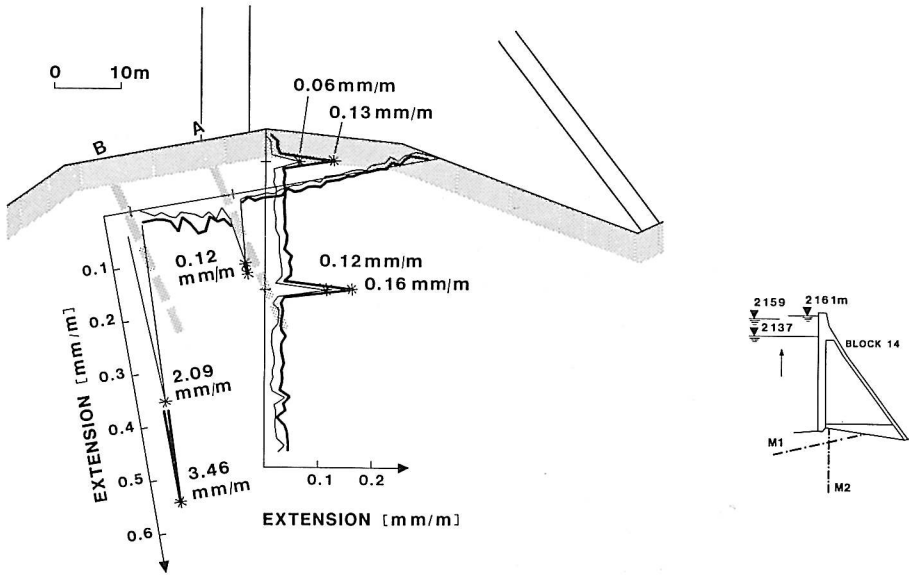
Fig. 8. Distribution of strain along the boreholes M1 and M2 due to increase of water level

The question of whether only one single joint or more of them opened and closed within the 1 m base length of the measurements causing a deformation of 3.67 mm/m (Fig. 10) is of no practical relevance. Let us now consider more closely the observed strain distributions in Fig. 8. The striking feature of this figure is the great sensitivity of the strain developments to the increase of the water level at this final stage of reservoir filling. The strains brought about by the last 2 m in water level increase are about the same as the strains caused by the preceding 22 m in the filling sequence.

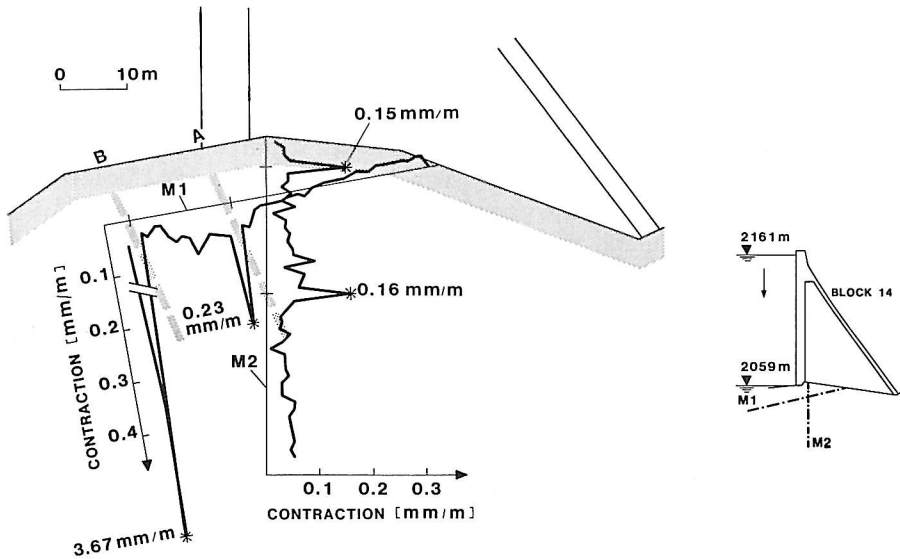
Fig. 9. Distribution of strain along the boreholes M1 and M2 due to complete fall in water level

From the observations of the crest deflection and also from previous borehole extensometer measurements, it was noticed that large deformation of the structure starts only at a water level of approx. 2140 m. It is, therefore, not surprising to see from Fig. 9 that the emptying of the reservoir causes a complete rebound of these strains shown in Fig. 8. The three installed boreholes M3, M4 and M5 at block 16 (Fig. 10) permits a rather complete picture of the deformational behaviour of the bedrock to be obtained. Apart

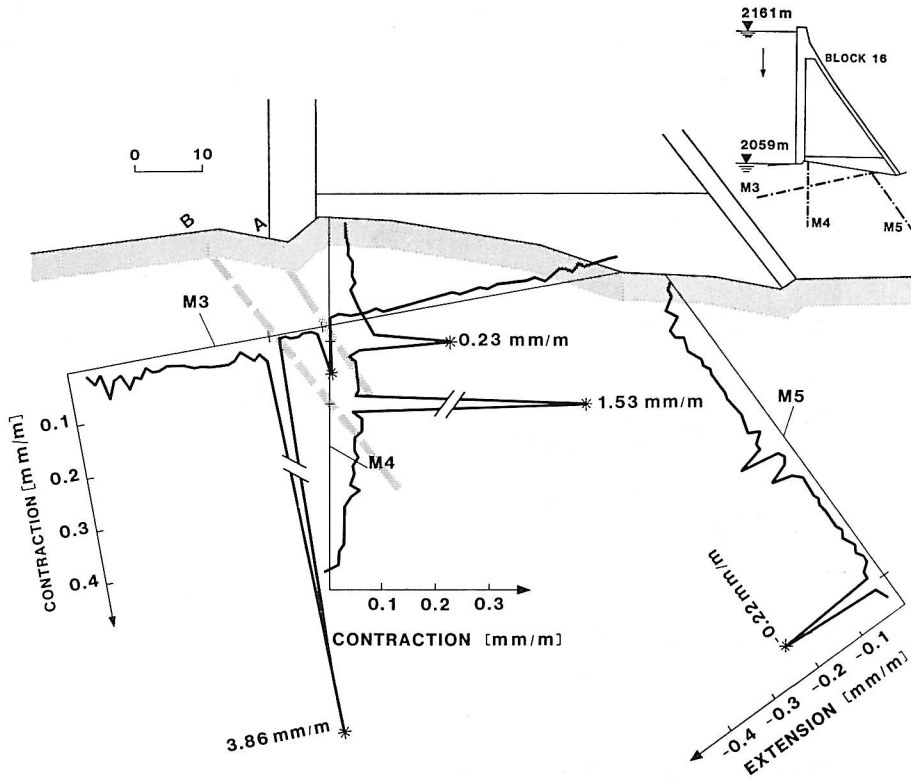
Fig. 10. Distribution of strain along the boreholes M3, M4 and M5 due to complete fall in water level

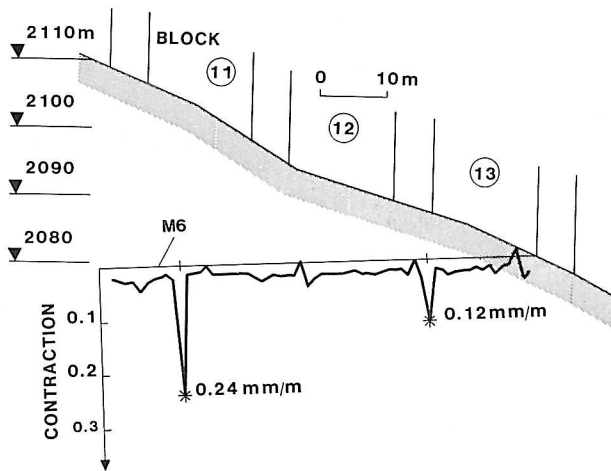
Fig. 11. Distribution of strain along the borehole M6 due to complete fall in water level

from the peaks, the strain distribution reveals the “normal behaviour” of the rock as well. The deformations observed in the vertical boreholes are surprisingly deep-seated. This fact, however, was also confirmed by finite element studies. The easy appraisal of the stress changes in the dam foundation due to the reservoir emptying allows the in situ Young’s modulus of the rock mass to be back-calculated. Using an average strain value of  $0.05 \text{ mm/m}$ , i. e.  $5 \times 10^{-2}$  obtained from the borehole M4, one obtains a Young’s modulus of the rock mass of  $H=30,000 \text{ N/mm}^2$ . This value only slightly differs from the one determined in the laboratory on intact rock specimens. The occurrence of only few active joints and the high rigidity of the rock mass confirmed the excellent overall rock conditions at the Albigna dam site. The strain variation along the measuring line M3 (Fig. 10) exhibits a change in sign just below the heel of the dam. The decrease in shear stresses transmitted from the dam to the rock causes compression strains upstream the dam and extension strains below the base surface. The borehole M6 (Fig. 11) was oriented in such a way that it crosses the

principal joint sets 1 and 2 at a steep angle. The remarkable peak in the strain distribution may be an indication for the active joint which was most probably one of the causes for the difficulties arising during the first reservoir filling in 1960.

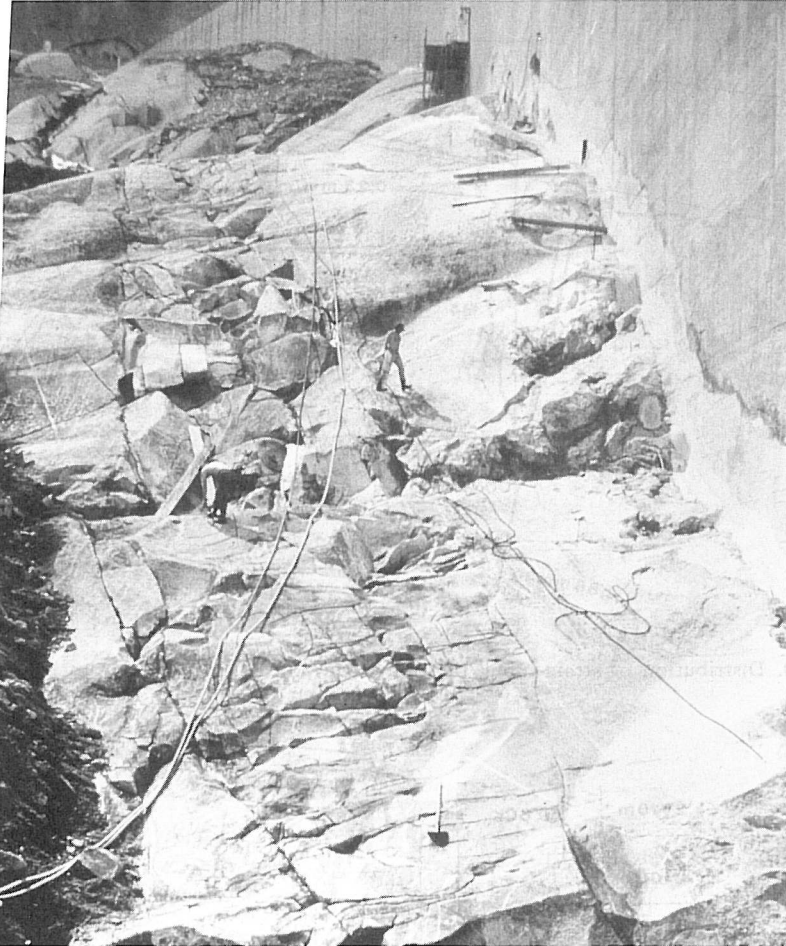
of a mud layer from the reservoir bottom adjacent to the toe of the dam, a set of longitudinal cracks on the rock surface could be observed which were obviously associated with the above-mentioned open joint B (Fig. 12).

Fig. 12. Longitudinal cracks on the rock surface at the upstream toe of the dam seen after removal of mud

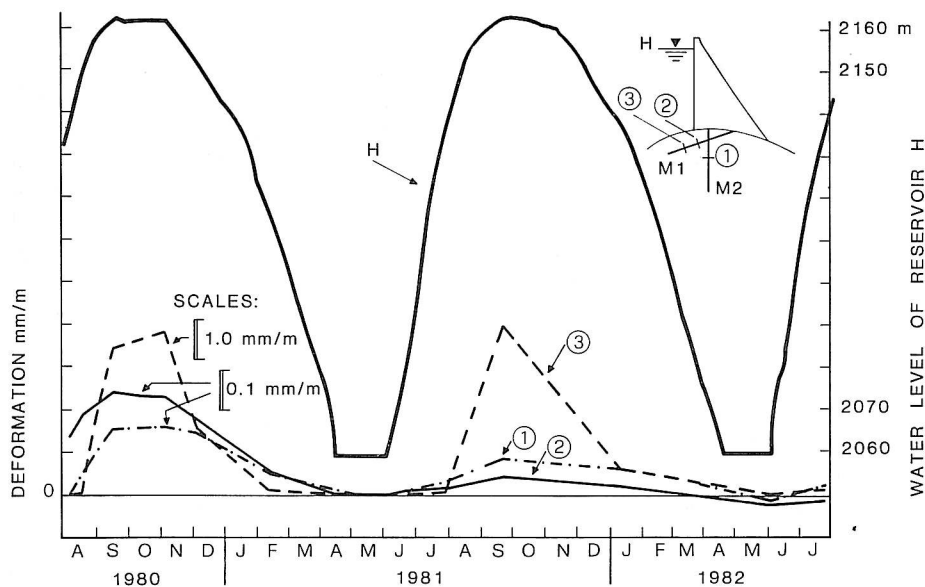
Fig. 13. Relation between reservoir water level elevation, time, and the opening of the particular joints 1, 2 and 3 at block 14

In Fig. 13 the opening and closing of some selected active joints at block 16 are related to the reservoir water level and time. It can be seen that the first readings with the Sliding Micrometer were performed in the period August 1980 and they continued up to the end of 1982. The frequency of the readings decreased with time because later the measurements only served for control purposes. The remedial measures to stop the underseepage of the dam were also carried out in the summer of 1980. They resulted in a sharp decrease of water loss (Fig. 5). The primary purpose of the measures taken was to prevent the water from direct access to the longitudinal open joints. Therefore, a neoprene water sealing was installed reaching about 4 m high on the dam heel and extending to a maximum of 8 m on the cleaned rock surface thus forming an L shape. The width of the neoprene strip varied along the dam heel according to the distance of the B joints from the dam. The total length of this water sealing carpet amounted to 240 m, which accounted for about 60% of the crest length. To ensure a tight sealing of this extraordinary size different technological problems had to be solved. Preliminary investigations concentrated on the question of adhesion between neoprene and concrete and neoprene and rock. The prevention of squeezing of the neoprene into open fissures acted upon by the 100 m reservoir head was a major concern. Special attention was paid to allow for large local strains in the vicinity of the active joints A and B exhibiting opening and closure.

The loss of water measured on the left bank valley side north of the block 11 could be decreased by these measures from 11 l/s to max. 1.5 l/s. The joint deformations (Fig. 13) also decreased except from the active joint B as indicated by the curve 3 which means that the water must have found its way to this joint. Fortunately, due to its sufficient distance from the heel of the dam, this joint has no influence on the underseepage of the dam. It obviously does not reach the injection curtain.
