Publication in the Czech magazine "Geotechnika", issue 1/2003 (March 2003)

## USE OF GEOTECHNICAL MONITORING IN REMEDIATION PROJECT OF AN UNSTABLE SLOPE

Daniel Naterop, Marek Záleský

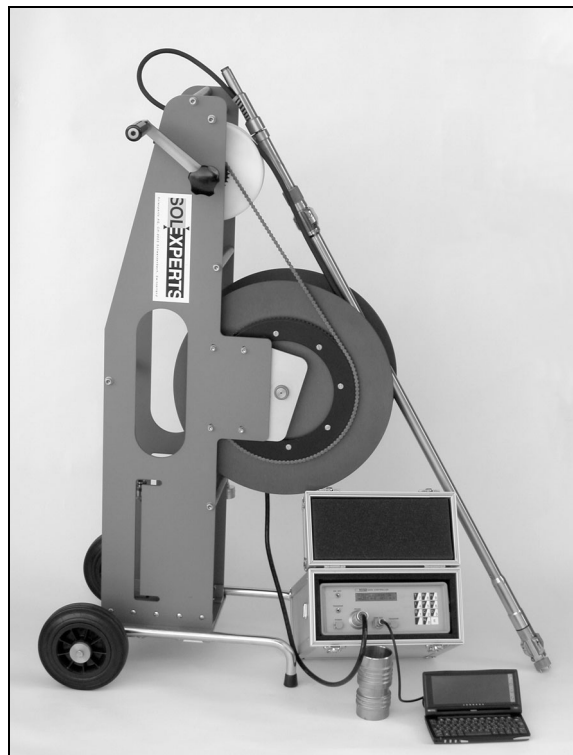
Fig. 1 Equipment for measurement.

Vertical deformation  $z$  and horizontal displacements  $x$  and  $y$  can be obtained with the TRIVEC probe (Fig. 1). It is a combination of a high precision extensometer and inclinometer. Resolution of the extensometer is 0,001 mm/m, its accuracy (mean error) is  $\pm 0,003$  mm/m. Both inclinometer sensors work with resolution 0,005 mm/m and accuracy (mean error) 0,05 mm/m. The borehole is instrumented with telescopic casing TRIVEC. The casing is manufactured in 1 meter long pieces made of PVC tubes fitted with telescopic coupling - brass measuring marks. The tubing pieces are connected with screws. Flexible casing grouted in the borehole with cement-bentonite grout is connected with the surrounding massif and follows all its vertical and horizontal deformations. The borehole should be deep enough in order to reach the stable rock or subsoil with the casing toe, which should be at least 3 meters deep in the stable subsoil. Then the bottom of the boring can be a reference point - in the case of measurement with "fixed toe".

The measurement equipment consists of the TRIVEC probe, which is lowered into the casing by a winch with Kevlar fibres reinforced data cable. The probe is connected to the readout unit Solexperts Data Controller, from which the measured data are transferred to a palmtop (i. e. HP Jornada), Fig. 1. Continuous registration and control of results is done by programme TRIVEC. The massif deformation is measured in 1meter intervals, always between two measurement marks. The guide rods are used to operate the probe and rotate between the measurement and sliding position. The measurement is taken twice in the same couple of measuring marks in order to assure and check its accuracy. In the measurement position is at first measured the vertical deformation z, then x and y in the “first location”. Afterwards is the probe 180° rotated to the “second location” and deformations x, y are measured once more. Thereafter the probe is rotated back to the first location and moved to the following measurement position. At the first time, the measurement is taken in the downward direction – from the top to the bottom of the borehole and second time upwards. In order to maintain the accuracy of measurements, the probe should be calibrated in a calibration device prior and past a field measurement. The factors gained from the calibration measurement are used for evaluation of field measurements.

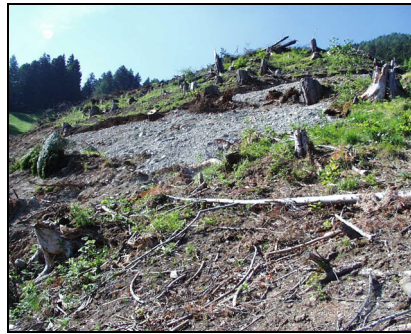
Fig. 2 Slope prior to excavation, May 2001. After /2/ Frodl.

First of all, a dense forest had to be cut down (Fig. 2). Because the slope is almost inaccessible, a temporary cableway was constructed to transport the excavated material. Temporary paths and irrigation channels running into concrete sumps were built during

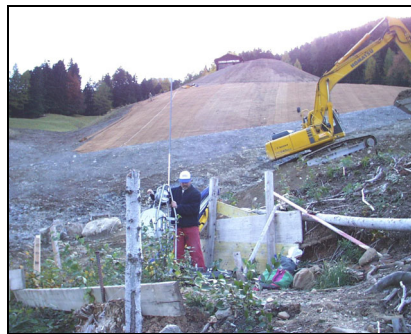
Fig. 3 New shape of the slope with coconut geo-mesh. After /2/ Frodl.

continuous lowering of the slope height. After finishing the terrain formation, the new surface of the slope was reinforced with coconut geo-mesh fitted by steel fasteners (Fig. 3). Later on, the slope was seeded with grass.

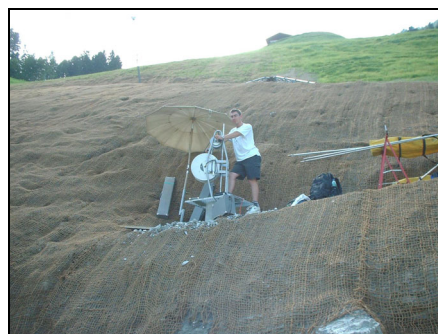
Fig. 4 Measurement in August 2002. After /2/ Frodl.

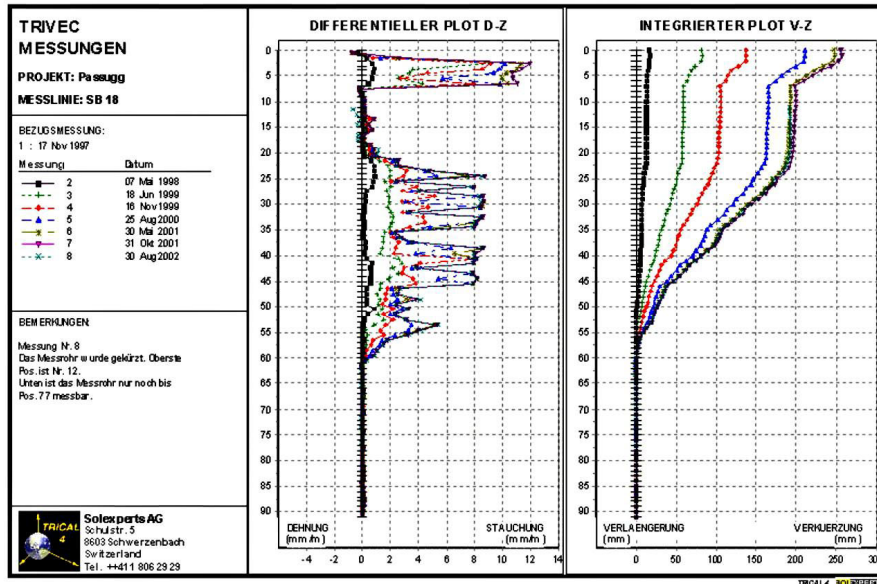
Fig. 5 Results of measurement in the sliding area, evaluated in programme TRICAL. Plots of vertical deformations z. Each curve corresponds with one measurement episode. The last curve displays the borehole which was 12 m shortened. After /2/ Frodl.

First measurement in the borehole is called “reference measurement”, to which are related the following ones. The development of deformations along the borehole can be monitored in time. The interval between measurements depends mainly on the velocity of massif deformation. The data gathered at the site are evaluated in the programme TRICAL, which enables also to archive the data from all measurements together with the corresponding calibrations. Values of each deformation components are plotted in two graphs: differential displacements - for each couple of measurement marks in the first graph and summation graph in the second plot. (Fig. 5, 6, 7). The results of more measurement episodes can give information about:

The graphs (Fig. 5, 6, 7) show the results of measurements since the year 1997. Large deformations were developed until May 2001, when the slope remediation began. During the years 1997 – 2001 the total horizontal displacement of the slope reached about 42cm accompanied by settlement of 35 cm (/2/ Frodl). Significant slow-down of sliding appeared after partial unloading of the slope, which is proved by the measurement in October 2001. During the following excavation of 12 meters of height of the slope was also the casing 12 meters shortened. Afterwards, the casing was cleaned and at this time last measurement was done in August 2002 (Fig. 4). The results of the last measurement (Fig. 5, 6, 7) show the shortened borehole and the effect of unloading of the slope and its springing back. The

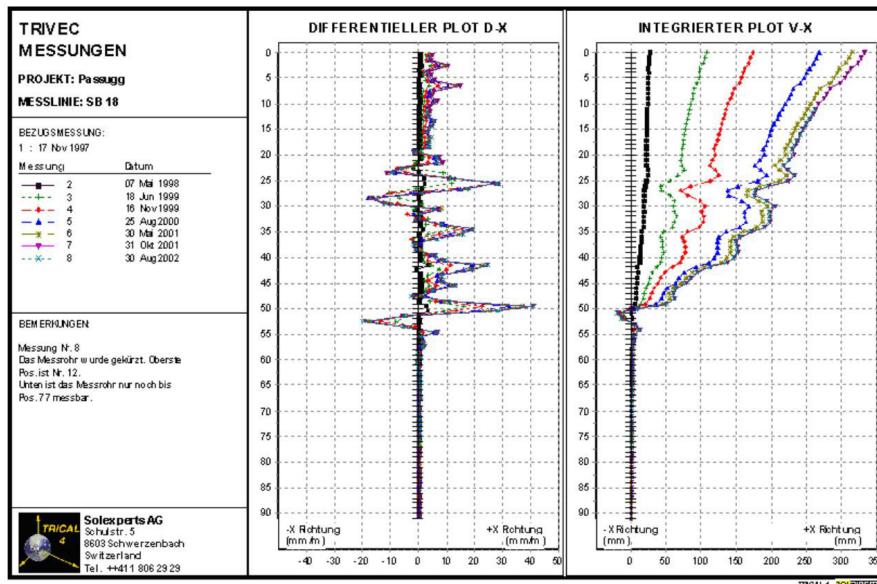
Fig. 6 Results of measurement in the sliding area, evaluated in programme TRICAL. Plots of horizontal deformations x. Each curve corresponds with one measurement episode. The last curve displays the borehole which was 12 m shortened. After /2/ Frodl.
