## Continuous Strain Monitoring in the Rock Foundation of a Large Gravity Dam

K. Kovári

G. Peter

### Summary

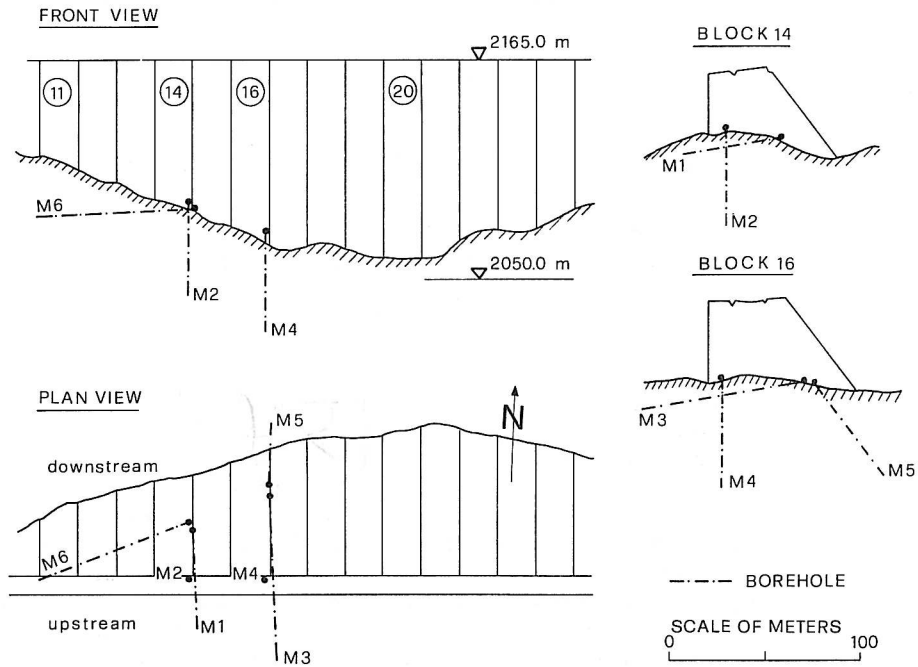
Fig. 1. Albigna Dam. The centre part indicating the location of the boreholes for strain monitoring

level for a period of 6 weeks drill holes were made in the course of additional grouting work, also in the vicinity of the foundation of block 11 (Fig. 1). One of these drillholes encountered a small joint, which was under high water pressure. In the process of drilling through the joint the water pressure was suddenly released, leading to a change in the support conditions for block 11, so that within a few hours a fine crack of about 0.1 mm aperture developed in the mass concrete. It extended from the base up to a height of 25 m and it could be clearly observed in the lower control galleries as well as in the hollow-joint of the block 11. It was noticeable that the crack path continued in a filled rock joint belonging to system 3 (Fig. 4). As a result of this crack a relatively small portion of the block which amounted to 900 m<sup>3</sup>, i. e. 2.5% of the total volume, was separated. Both for the stability and the state of stress in the block this portion was of almost no significance. The amount of water seeping into the hollow-joint of block 11 was approx. 2 l/sec. By means of grouting and upstream

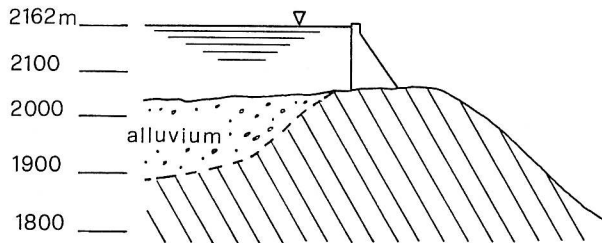
Fig. 2. Section through block 20 showing the marked rock ridge upon which the dam rests

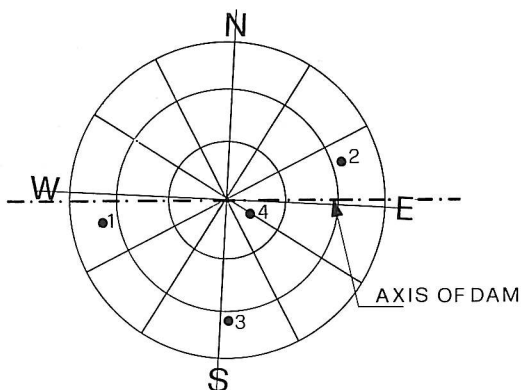
Systematic exploratory boreholes and the displacement measurements revealed that the crack penetrated at least 30 m into the rock formation and as a result of full reservoir filling it opened up to a width of 16 mm at the rock surface. This open joint belonged to the principal set 3 already mentioned (Fig. 4). The investigation of the flow path in the rock mass

Fig. 4. Main orientation of the four principal sets of discontinuities (lower reference hemisphere)
